CASE STUDY SAPPI SAICCOR

MODEL CUSTOMER

RIGHT FROM DAY ONE

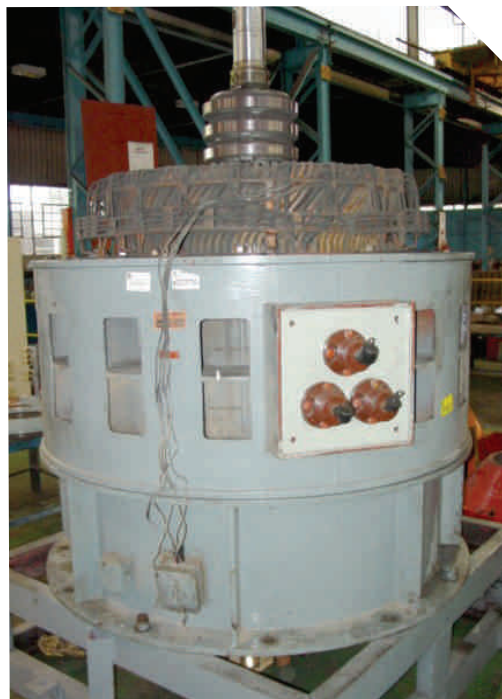
Early detection by Wearcheck of a bearing problem in the motor of this water intake plant at Sappi Saiccor, saved the company hundreds of thousands of rand.

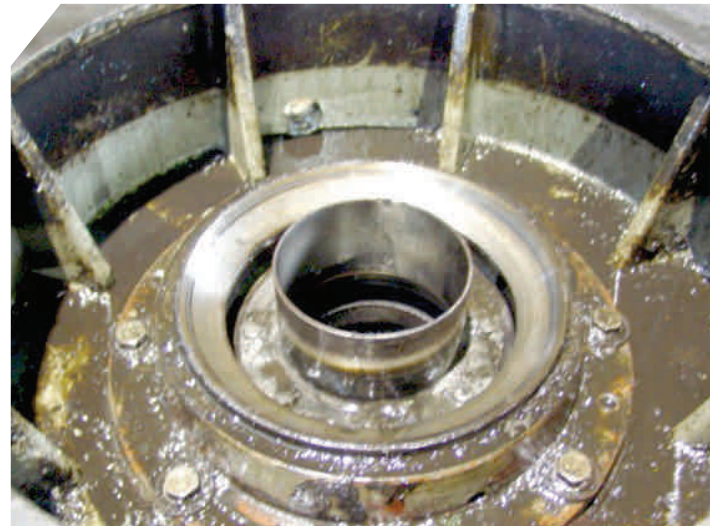
intake pumps, Sappi Saiccor's condition monitoring team was alerted to the problem.

When the motor was opened, the NDE bearing showed evidence of bearing creep or turning in the housing. They also found heavy wear metal sediment on the bottom of the bearing housing (see photograph below), the cage was broken and there was excessive wear on the rolling element and raceways.

Mr Tekete cited a recent example in which oil analysis saved the company a substantial amount of money. When Wearcheck detected increasing wear on the non-drive end (NDE) bearing of a vertically mounted 645 kW motor operating one of the company's water

The damaged NDE bearing which was replaced before the motor failed.

The company's two-weekly in-house vibration monitoring diagnosis confirmed there was a problem, and the motor was sent for an overhaul.

'If the bearing problem had not been detected early, the machine could have failed catastrophically, resulting in great financial losses,' said Mr Tekete. 'The replacement value of the motor alone is in excess of R500 000, without taking into account the cost of downtime and loss of production.'
